ESP32-P4 Chip Revision v3.x

User Guide v1.0

About This Document

This document describes differences between chip revision v3.x and previous ESP32-P4 chip revisions.

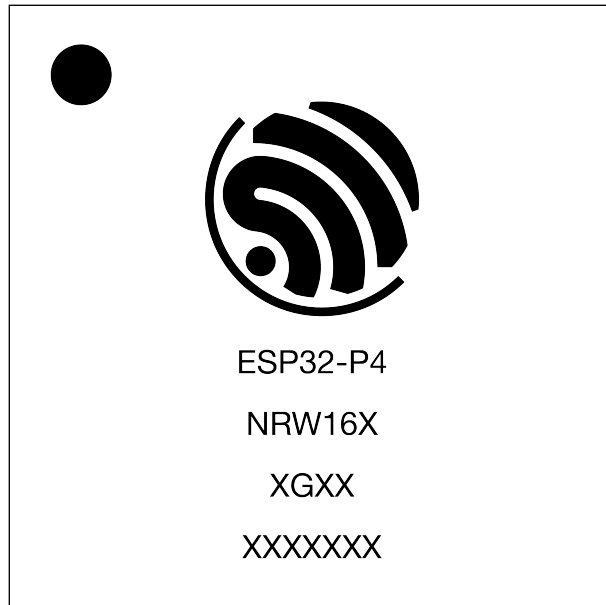
Figure 3-1. The label of ESP32-P4NRW16X

The figures above show the chip marking of chip revision v3.1: its manufacturing code is XGXX. For chip revision identification by chip marking, please refer to [ESP32-P4 Series SoC Errata](#).

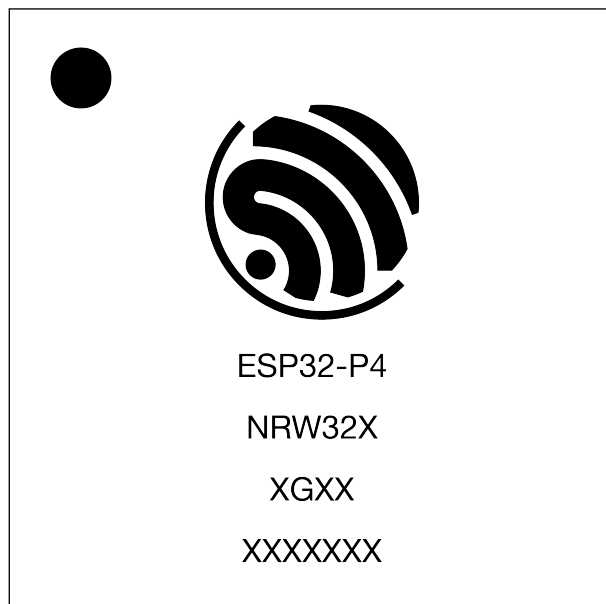
Figure 3-2. The label of ESP32-P4NRW32X
